12.LEFT CRANKSCASE/CRANKSHAFT/ BALANCE SHAFT

MXU 500

SERVICE INFORMATION-----	12- 2
TROUBLESHOOTING-----	12- 2
CRANK SHAFT AND BALANCE SHAFT REMOVAL/INSPECTION/INSTALLATION -----	12- 3
BEARING/OIL SEAL REPLACEMENT IN THE LEFT CRANKCASE-----	12- 6

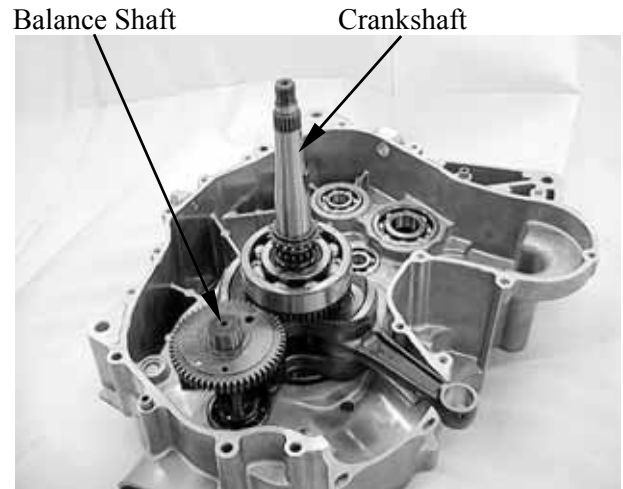
Remove the crankshaft and balance shaft together.

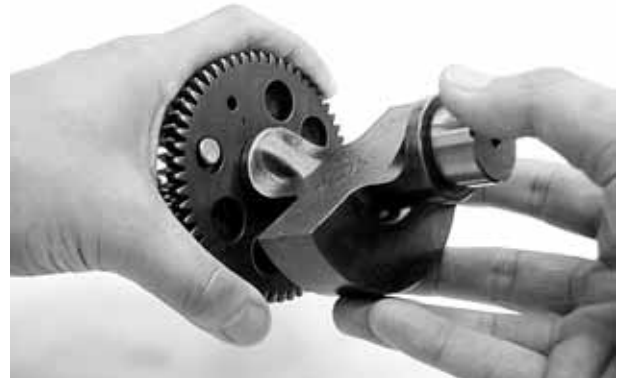
Balance shaft

Inspect the balance shaft gear teeth.
Burr/chips/roughness/wear → Replace.

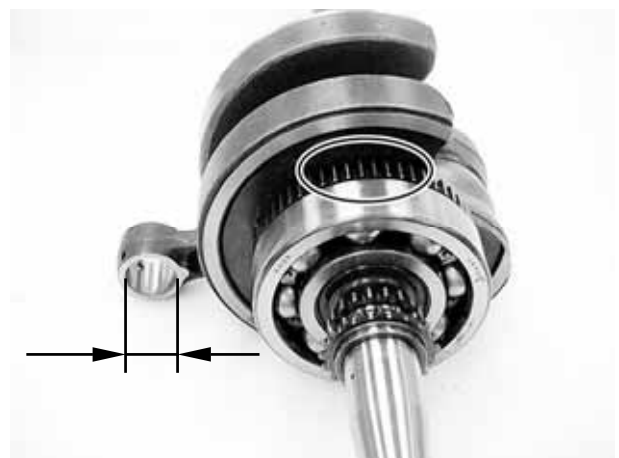
Inspect the crankshaft gear teeth.
Burr/chips/roughness/wear → Replace.

Measure the connecting rod small end I.D.

Service Limit (replace if over):
22.06 mm (0.8824 in)

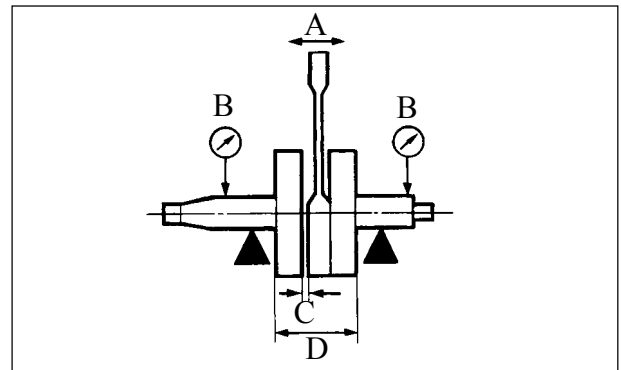
Measure the connecting rod small end free play (A).

Out of specification:

0.8 ~ 1 mm (0.032 ~ 0.04 in)

→ Replace the crankshaft.

Measure the crankshaft run out (B).

Service Limit (replace if over):

0.1 mm (0.004 in)

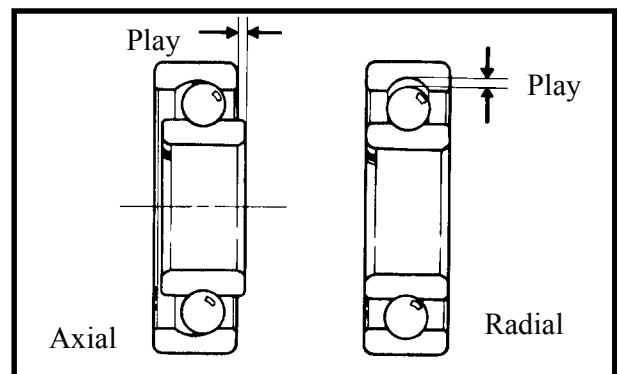
Measure the connecting rod big end side clearance (C).

Service Limit (replace if over):

Not USA type: 0.6 mm (0.024 in)

USA type : 0.8 mm (0.032 in)

Measure the crank width (D).

Out of specification:

72 ~ 72.05 mm (2.88 ~ 2.882 in)

→ Replace the crankshaft.

Turn the crankshaft bearings and check for excessive play.

Measure the crankshaft bearing play.

Axial : 0.2 mm (0.008 in)

Radial : 0.05 mm (0.002 in)

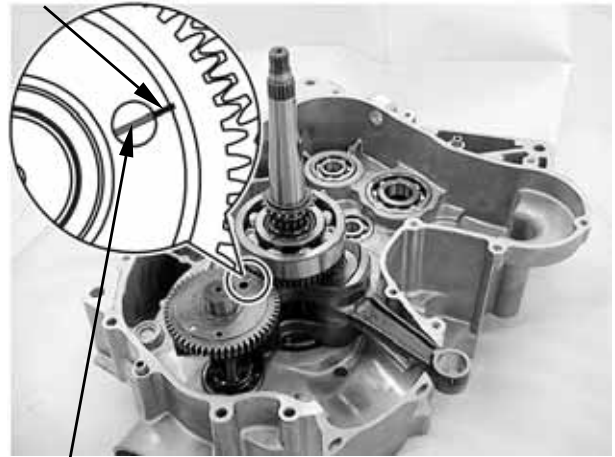
Install the balance shaft and crankshaft into the left crankcase.

- * Align the mark on the balance shaft with the mark on the crankshaft.

Mark (on the Balance Shaft)

Mark (on the Crankshaft)

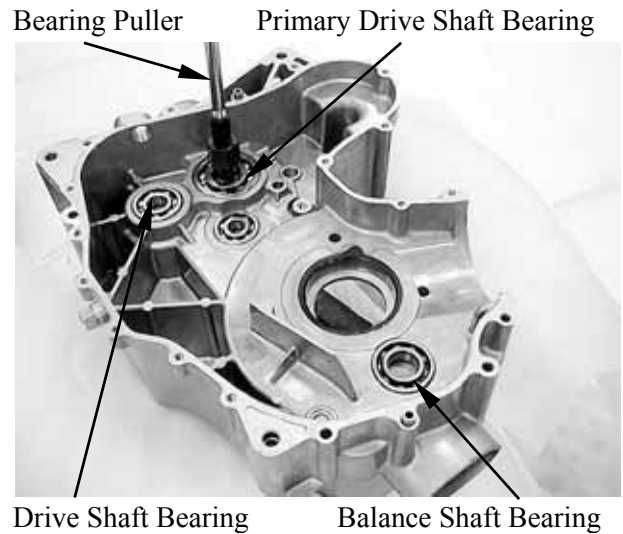
Remove the balance shaft/countershaft/primary drive shaft /drive shaft bearing by using the special tool.

Special tool:

Bearing puller A120E00037

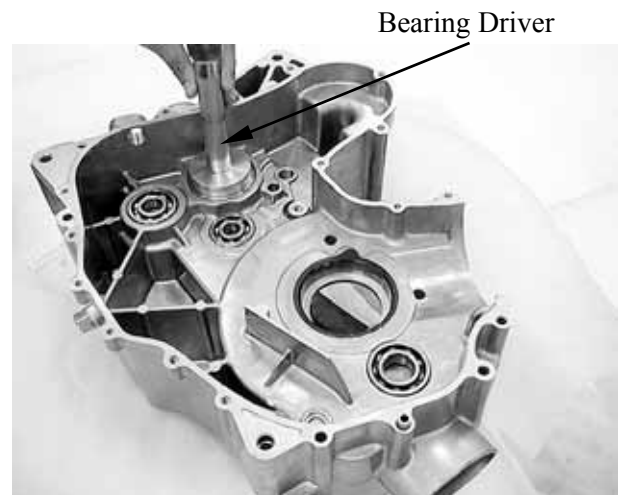
Install the new bearing by using the special tool.

Special tool:

Bearing driver A120E00014

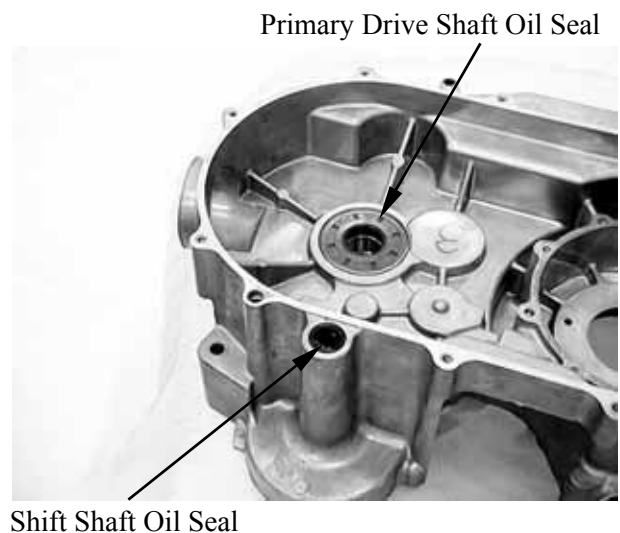
Check the oil seals
Wear or damage → replace
